Minerals Inspection Report

Mine Name: Leamington Cement Plant	Permit Number: M/023/0004	Mine Status: Active
Operator Name: Ash Grove Cement	Inspection Date: 04/07/2015	Permit Fees: Paid
Inspector(s): Wayne Western	Inspection Time: 10:35 - 11:00 pm	Bond Amount: \$6,857,000
Attendee(s): Josh Nelson, Gordon Jarrett	Weather: mild and sunny	Bond Escalation: 07/22/2017
Inspection Purpose: Routine inspection		Prior Inspection: 06/05/2014

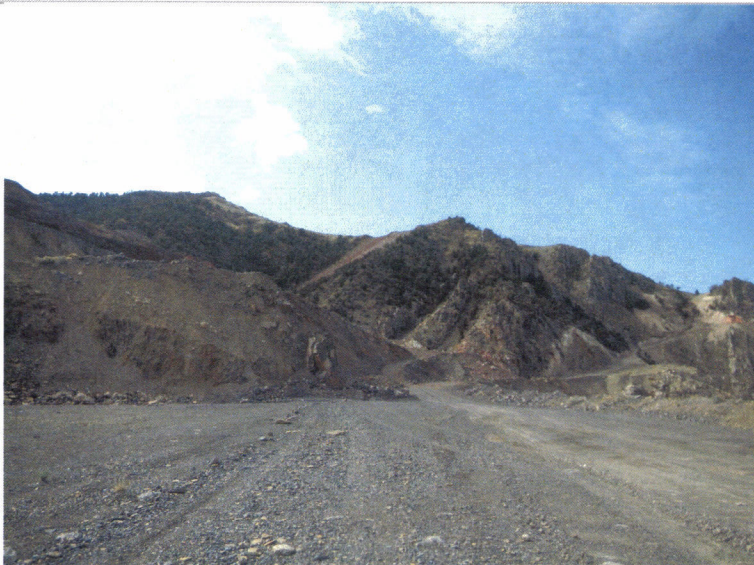
Mine looking south. Notice the highwalls on the left.

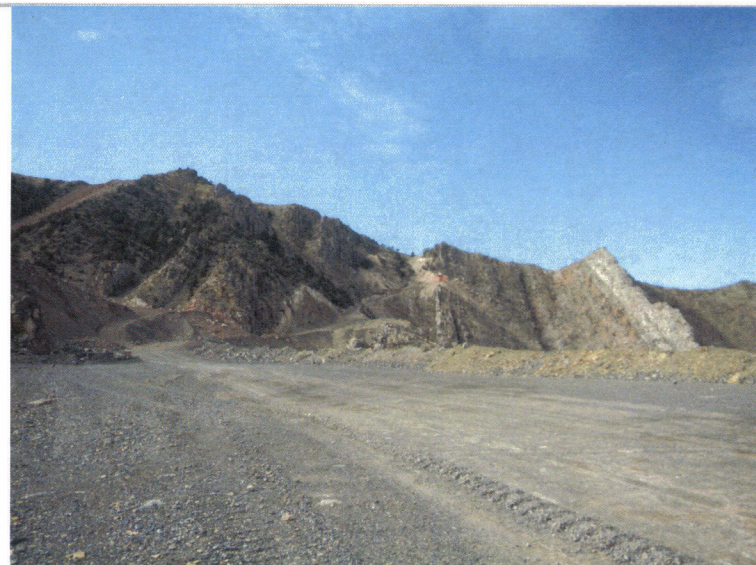
Mine looking south. Notice the road going up the mountain in the center of the photo. The Operator plans on doing more work on top the mountain later in the year.

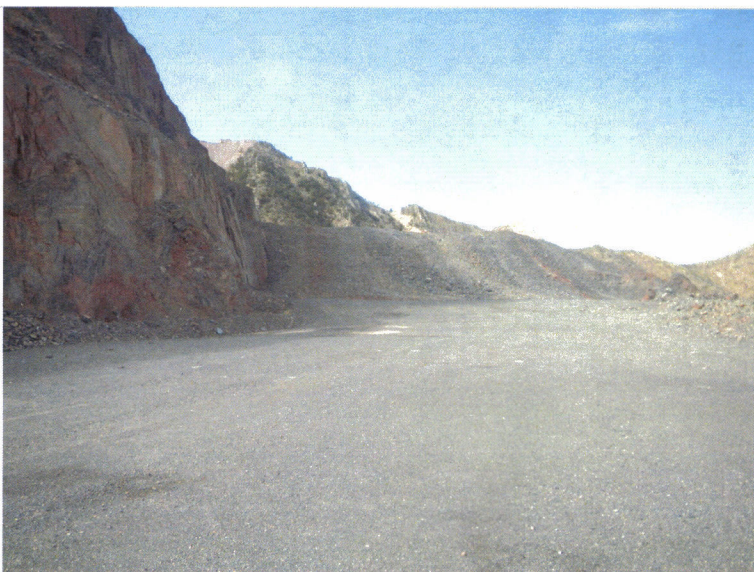
Close up of the highwalls

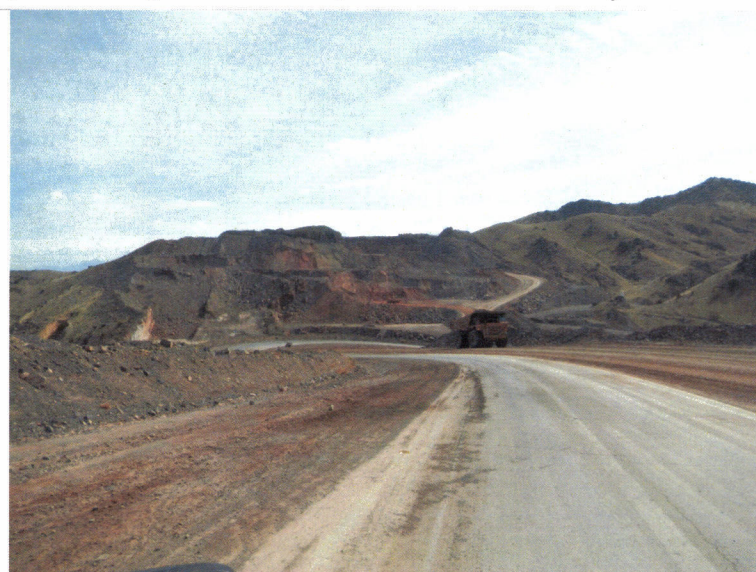
Looking south, notice the haul roads and the large trucks that are used.

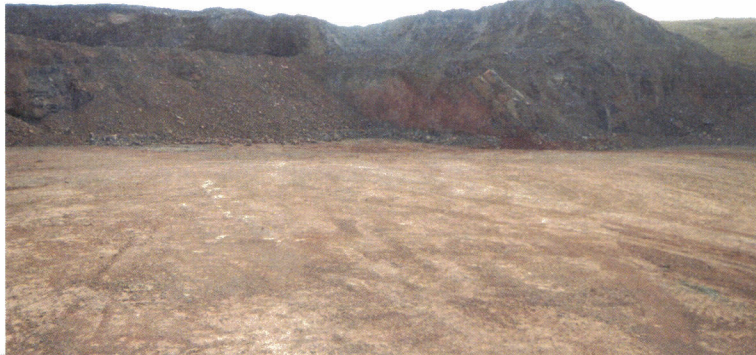
Material is pushed off the slope and then loaded onto trucks

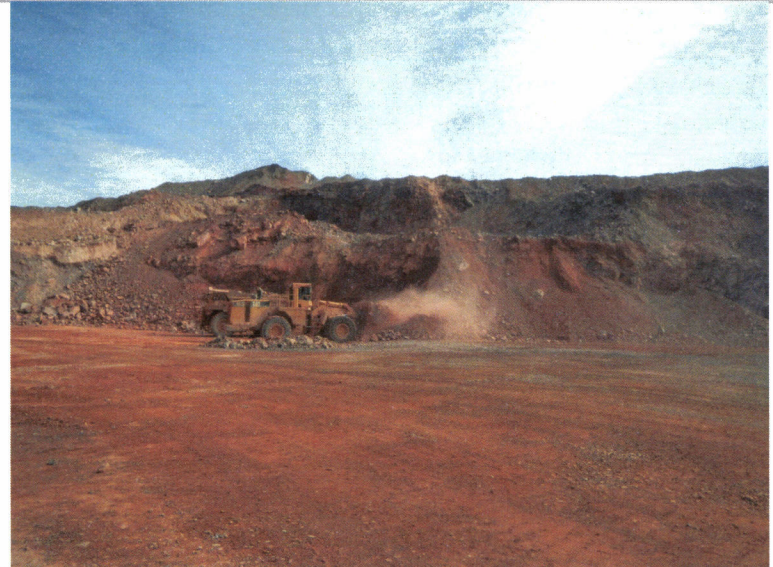
Truck and loader on site.

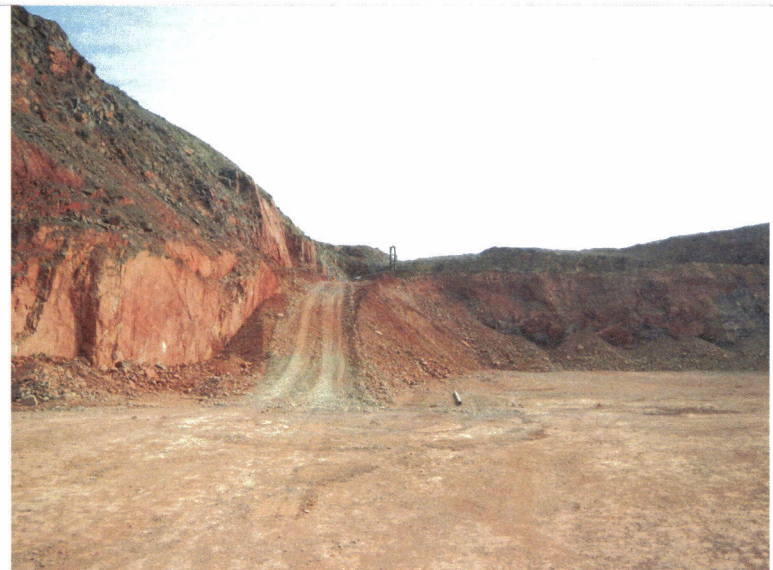
Notice the drill rig used for blasting in the center of the photo.
